TS-AMD-85741
October 1985

HISTORICAL AERIAL PHOTOGRAPHIC ANALYSIS OF WOOD TREATMENT FACILITIES

Montana

W. M. Mack
Environmental Programs
Lockheed Engineering and Management Services Company, Inc.
Las Vegas, Nevada 89114

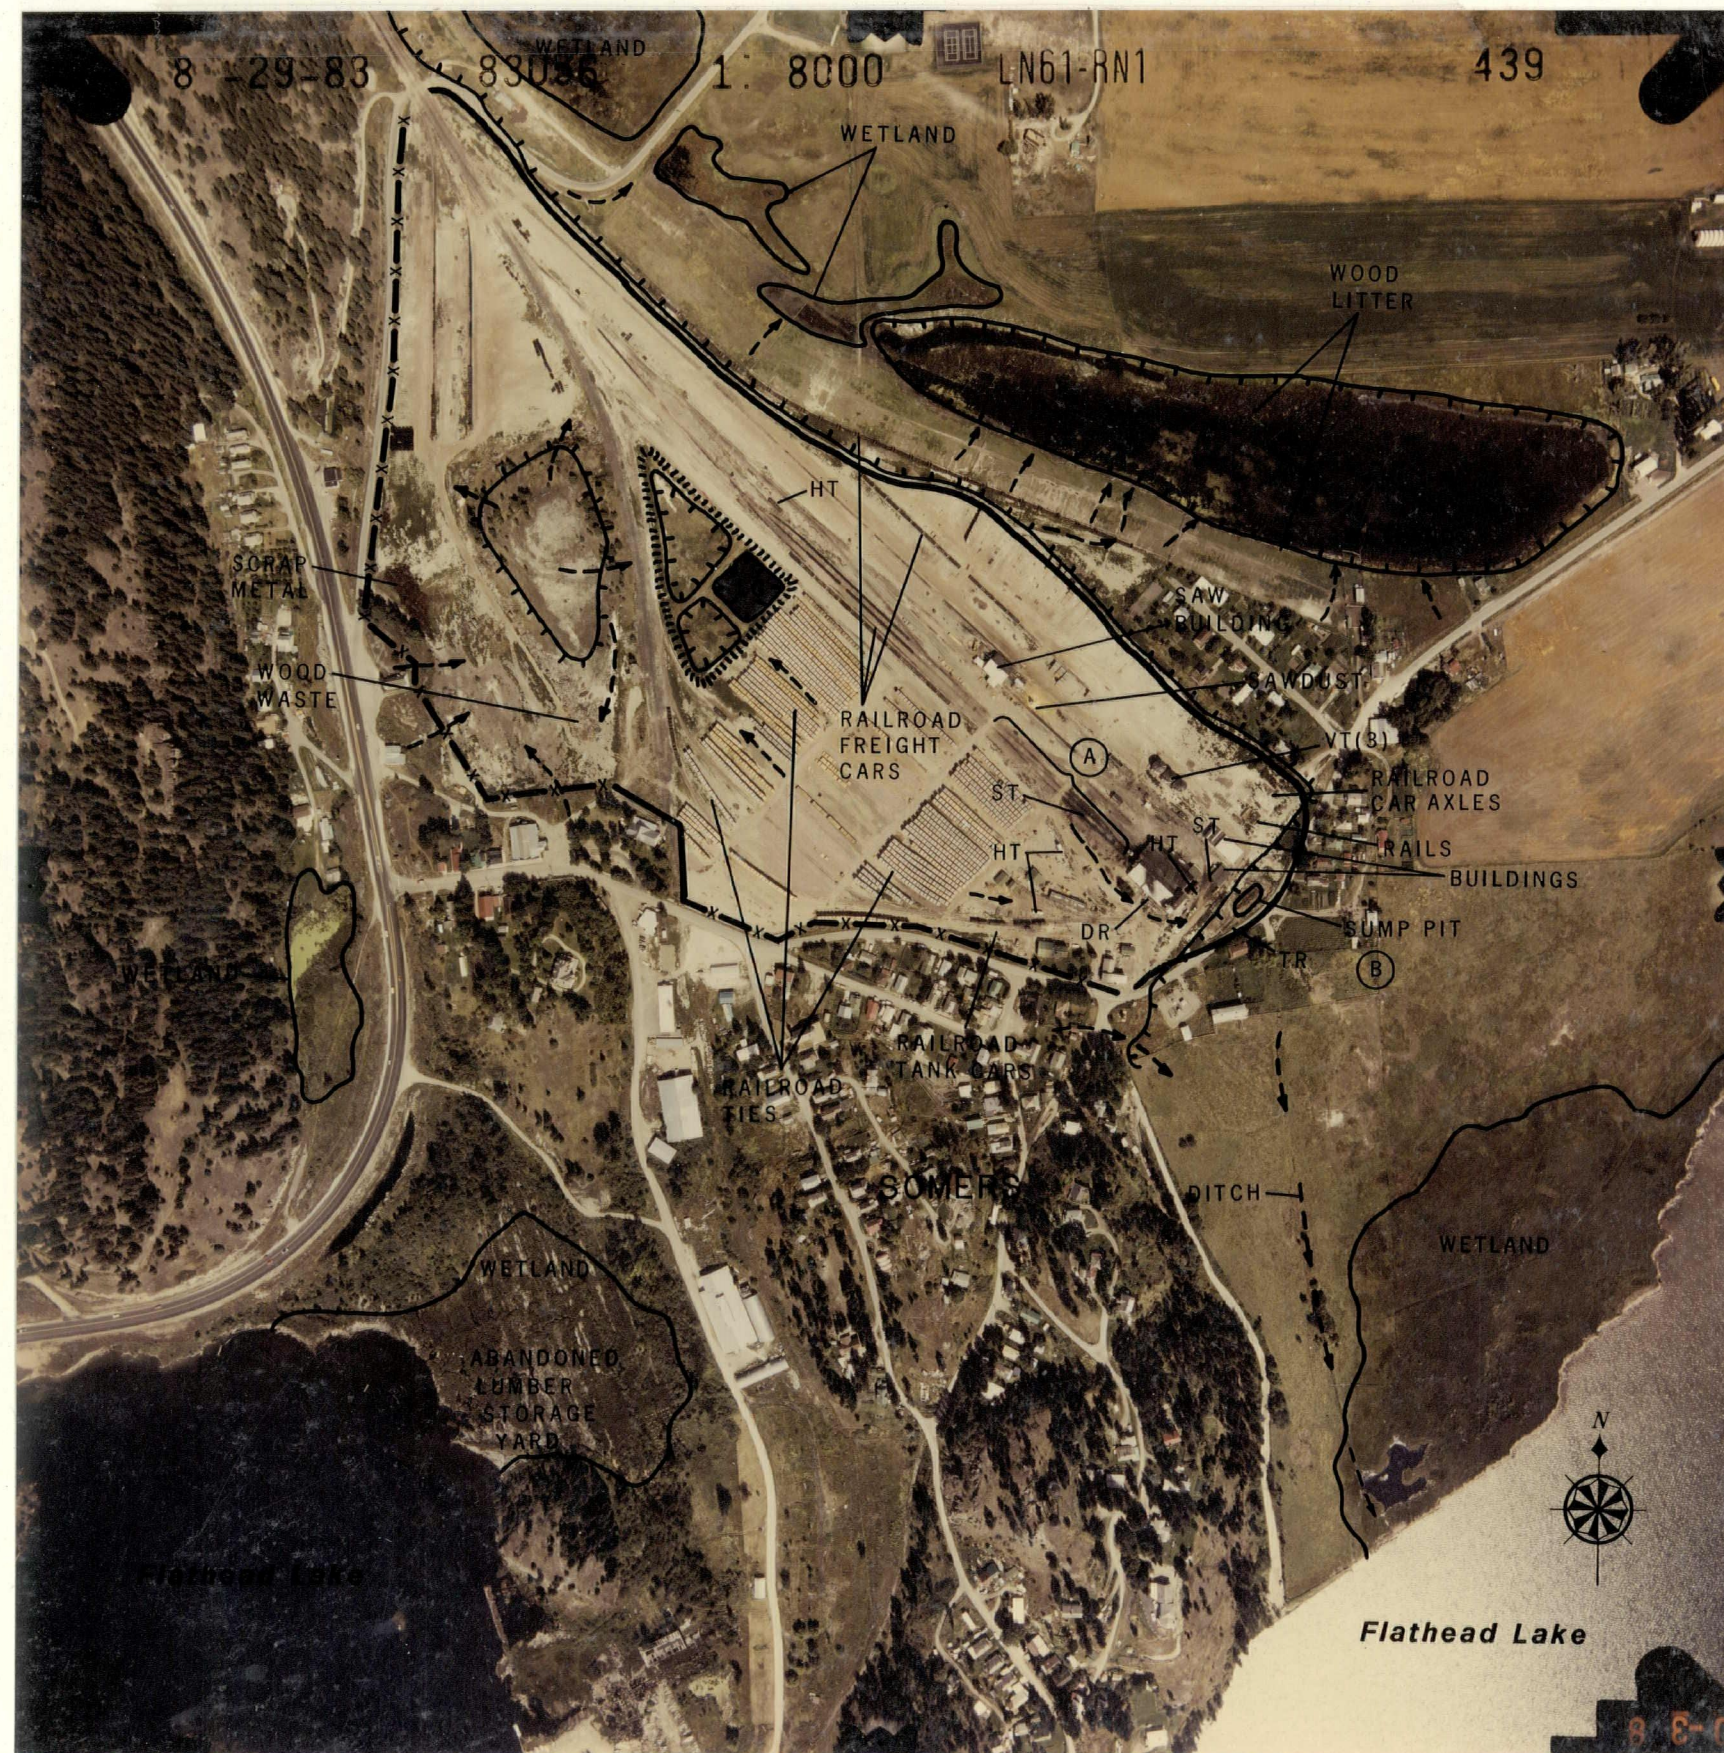
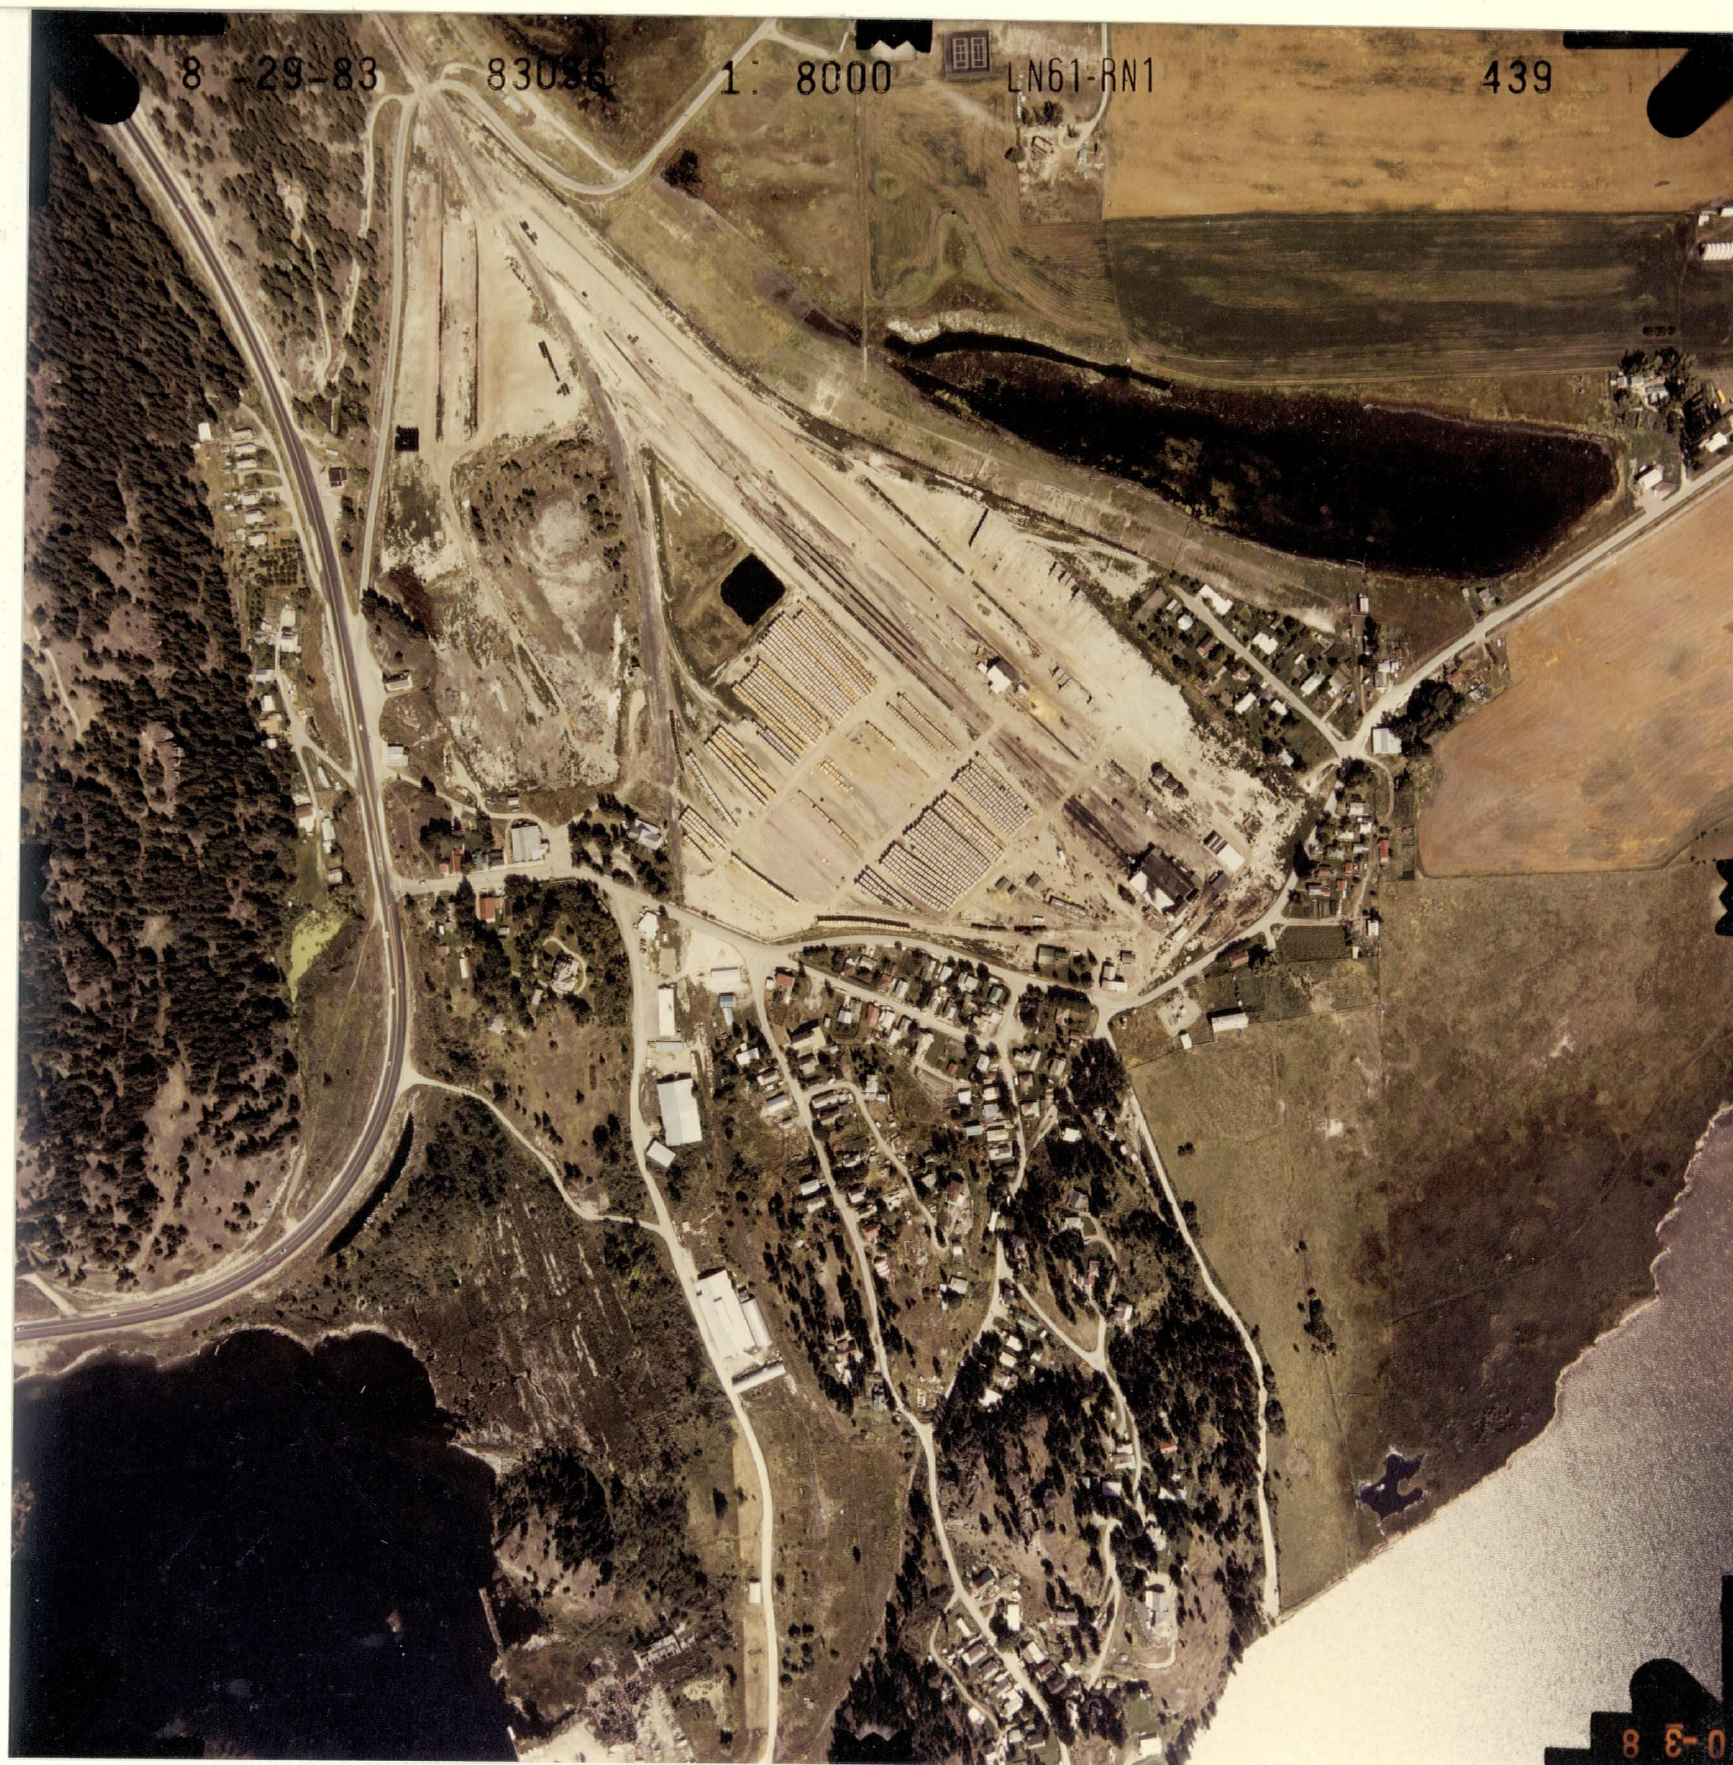
Figure 9. Burlington Northern Railroad, Somers Tie Treatment Plant, August 29, 1983. Approximate scale 1:6,100.

The 1983 photograph (Figure 9) shows an operational railroad tie treatment facility. The color photograph reveals widespread ground stains around the drip tracks (annotation "A") leading into the wood treatment building and throughout this processing area at the southeast side of the facility. Northwest of this stained area is a saw building with its associated piles of yellow sawdust. Three vertical storage tanks are on the north side of the wood treatment building and a sump pit is along its south side. Dark ground stains around the sump pit and trench at the east side of the site suggest the capture of spillage or leakage from the adjacent wood treatment building. There are no indications that waste liquid has escaped from this pit or that waste liquid from this wood treatment plant has been deliberately discharged into the natural drainage system. The sump pit, however, appears unlined and could potentially threaten ground water supplies.

Surface runoff from the northeast portion of the facility drains into an adjacent old oxbow lake; this body of standing liquid is now littered with wood debris. Drainage from the southern portion of the site flows southeast and is likely to reach Flathead Lake. It is likely this rainwater runoff could transport pollutants from the wood treatment areas into the natural drainage system and adversely impacts Flathead Lake.

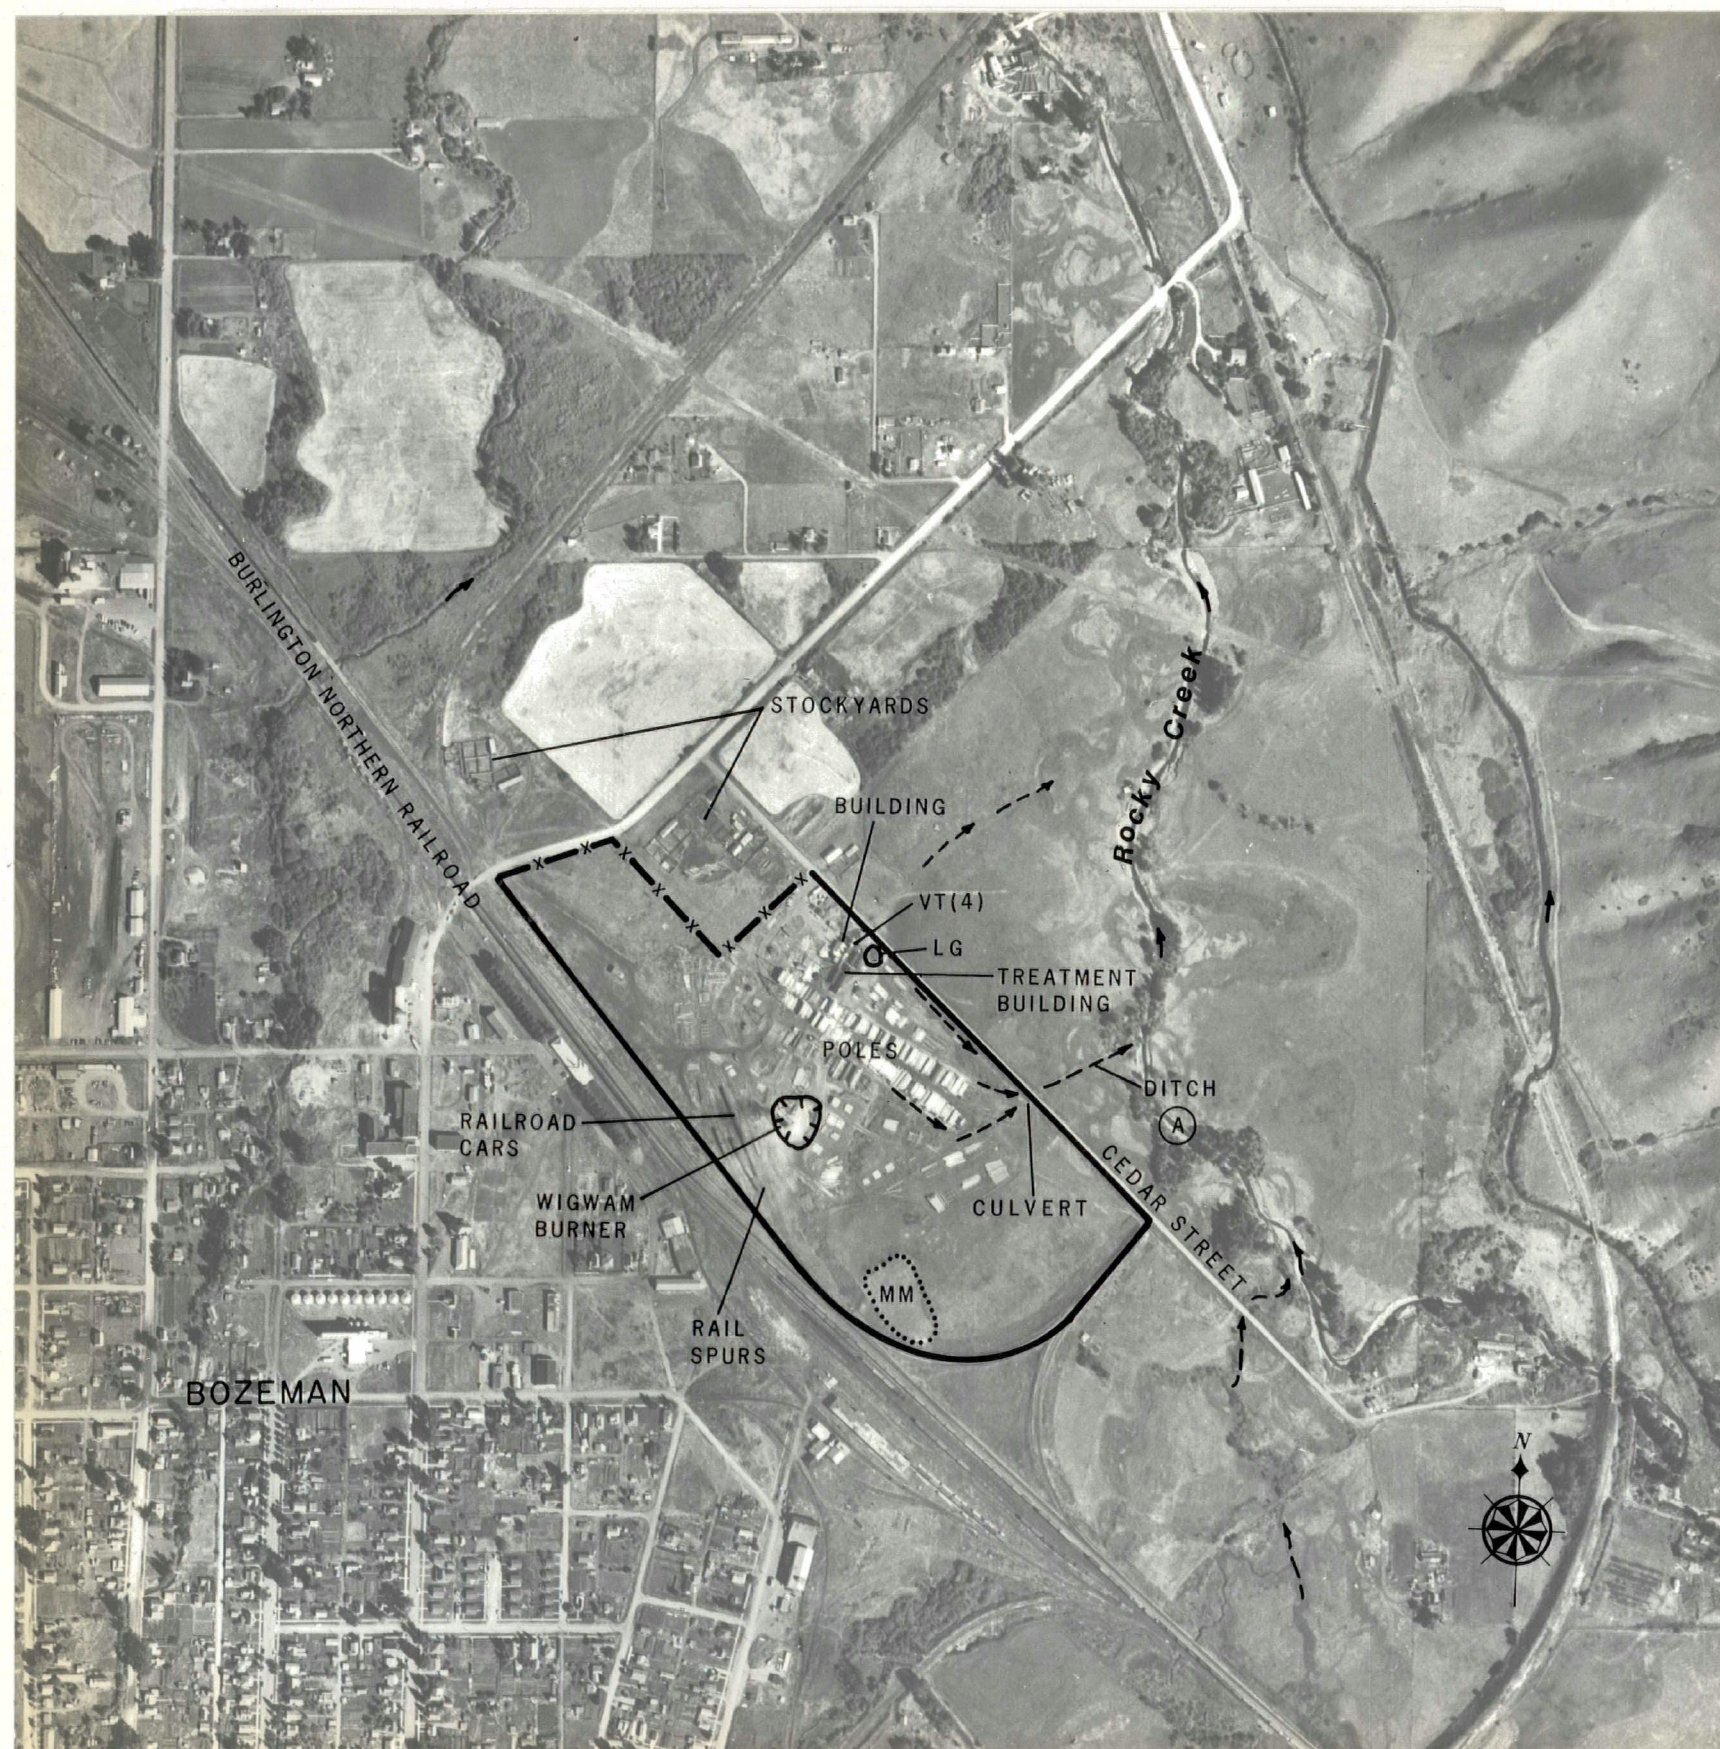
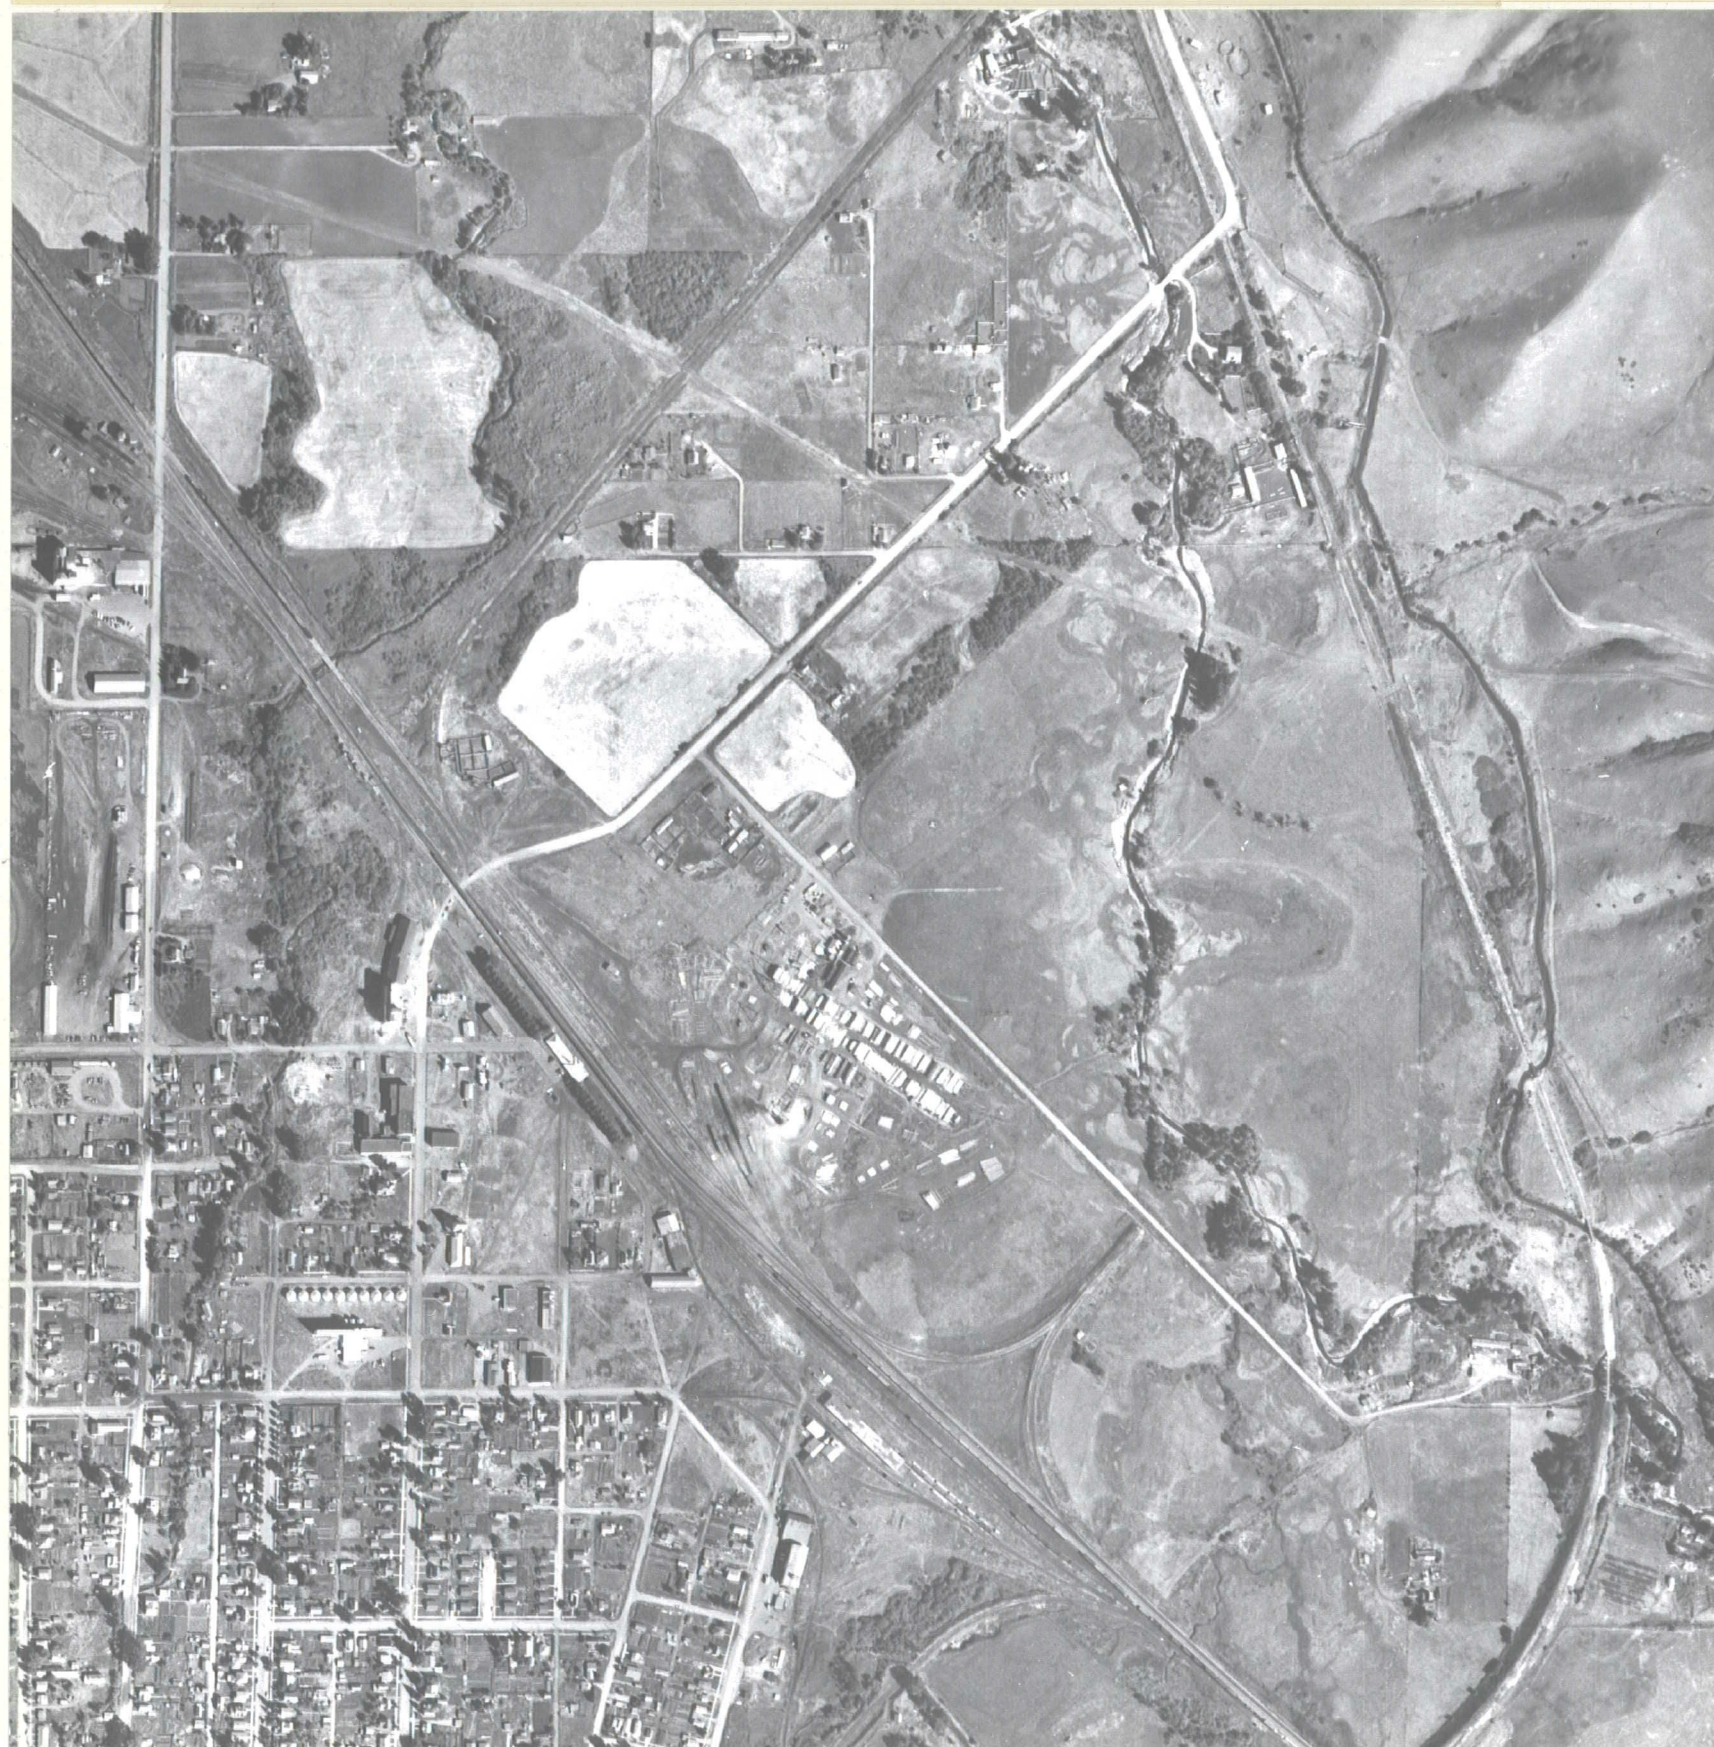
Figure 11. Idaho Pole Company, September 9, 1954. Approximate scale 1:7,050.

The facility is served by rail spurs from the Burlington Northern Railroad and Cedar Street road along its northeast perimeter. The site contains wood treatment buildings, chemical storage tanks, and large open storage yards containing treated and untreated wood poles. Near the center of the facility in a slight depression is a wigwam burner.

Surface runoff at the site flows southeast into a culvert under Cedar Street to a ditch (annotation "A") that empties into Rocky Creek. No visible leachate or vegetation stress can be identified from activities at this site.

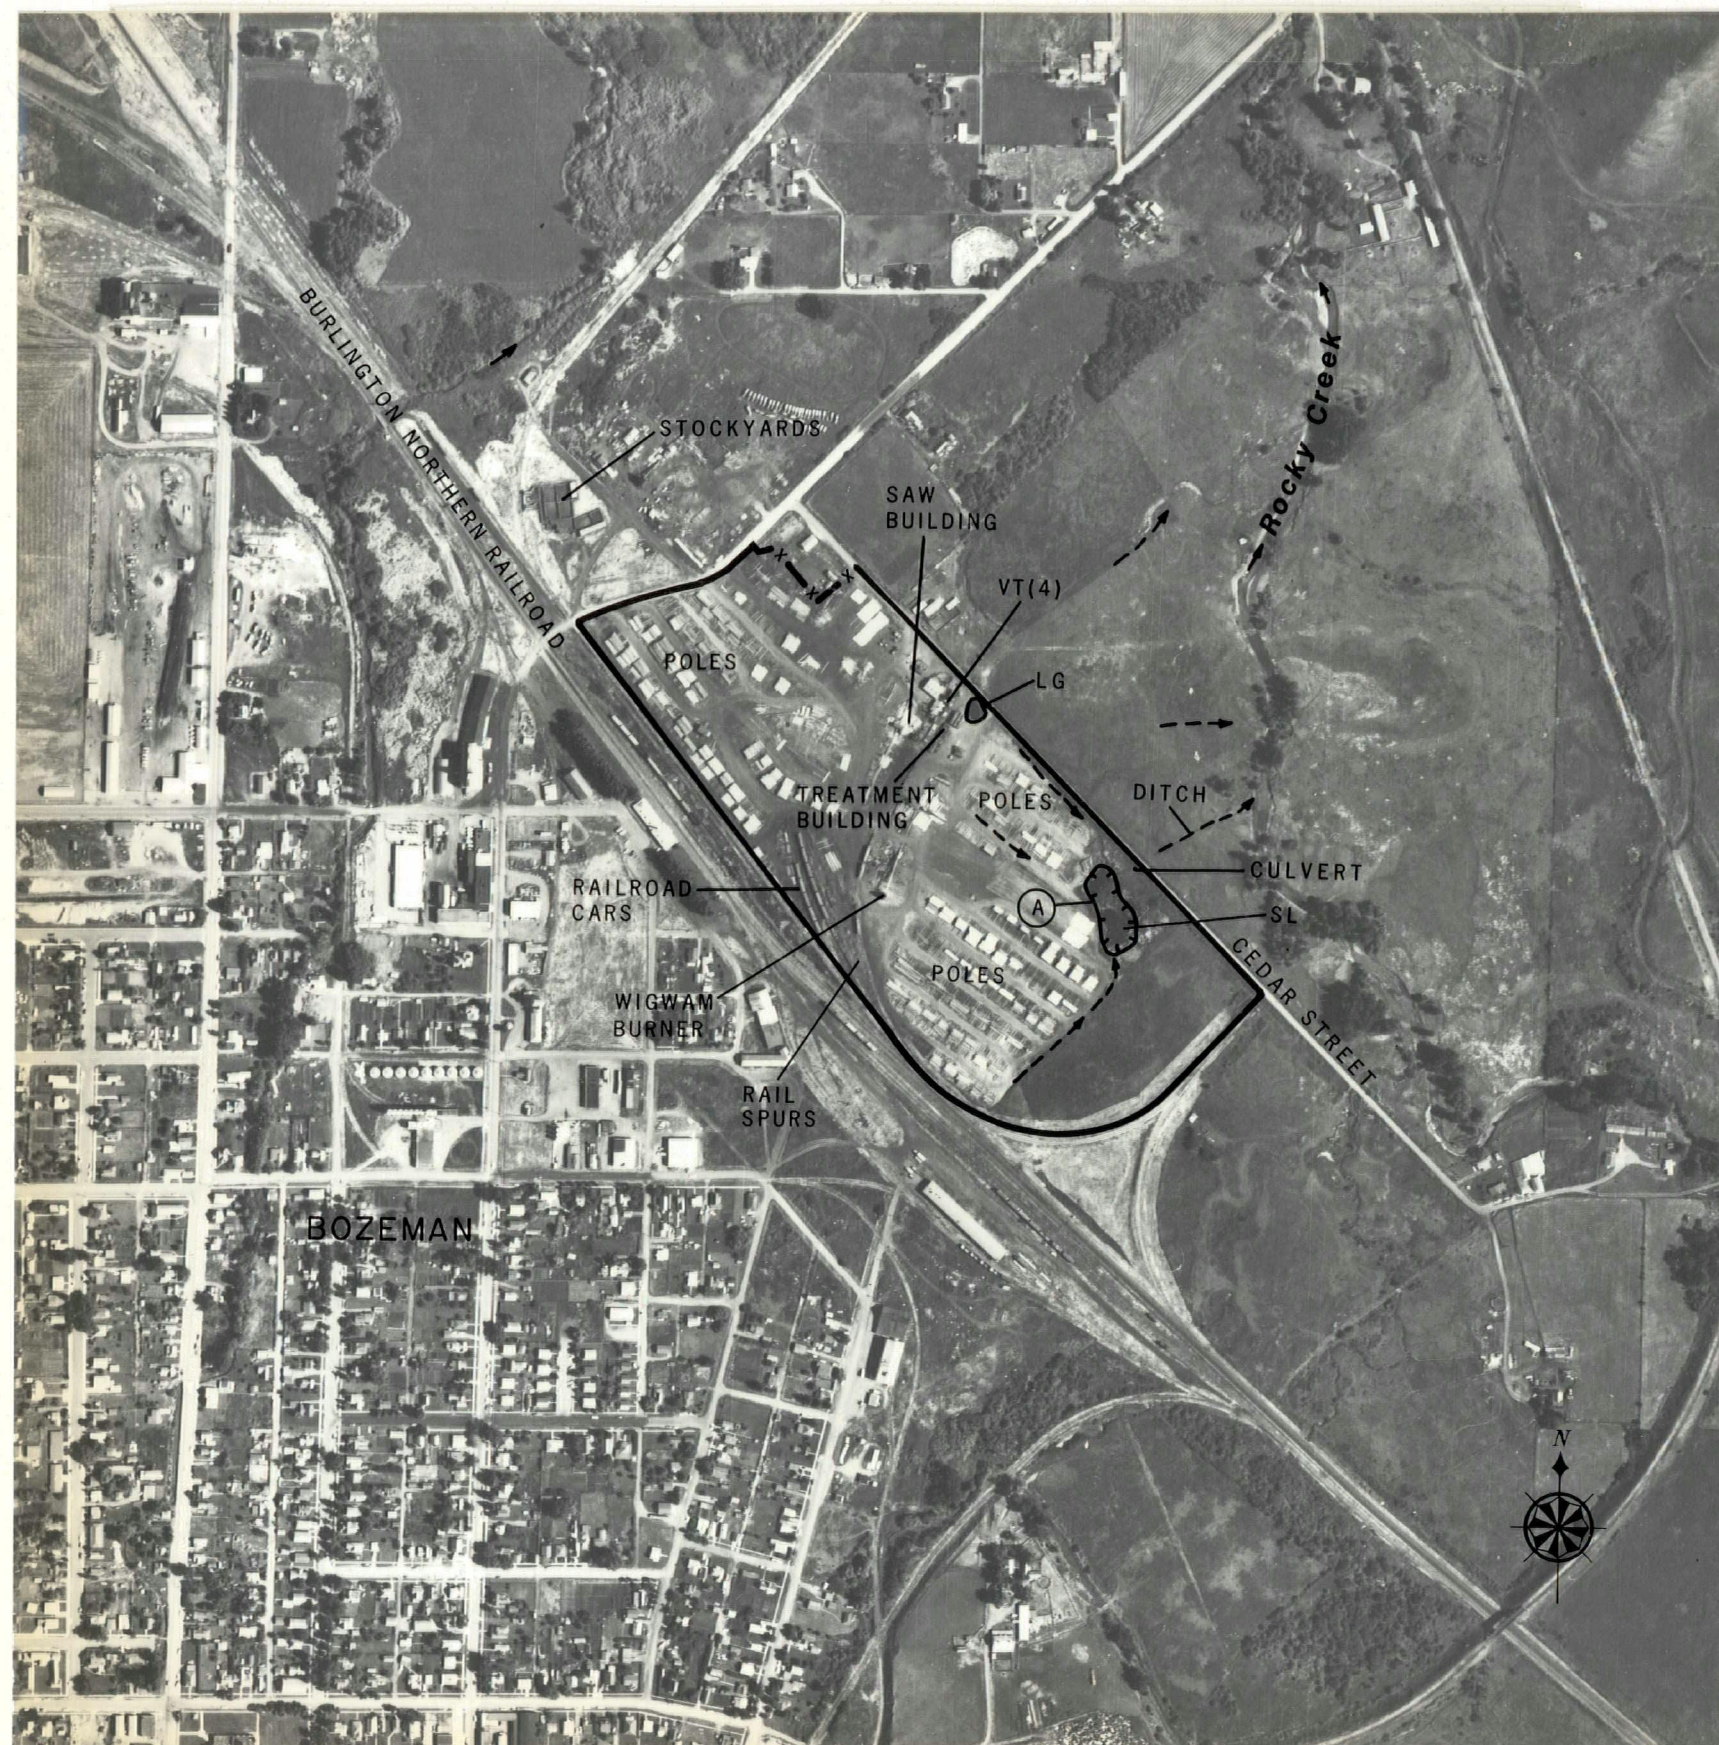
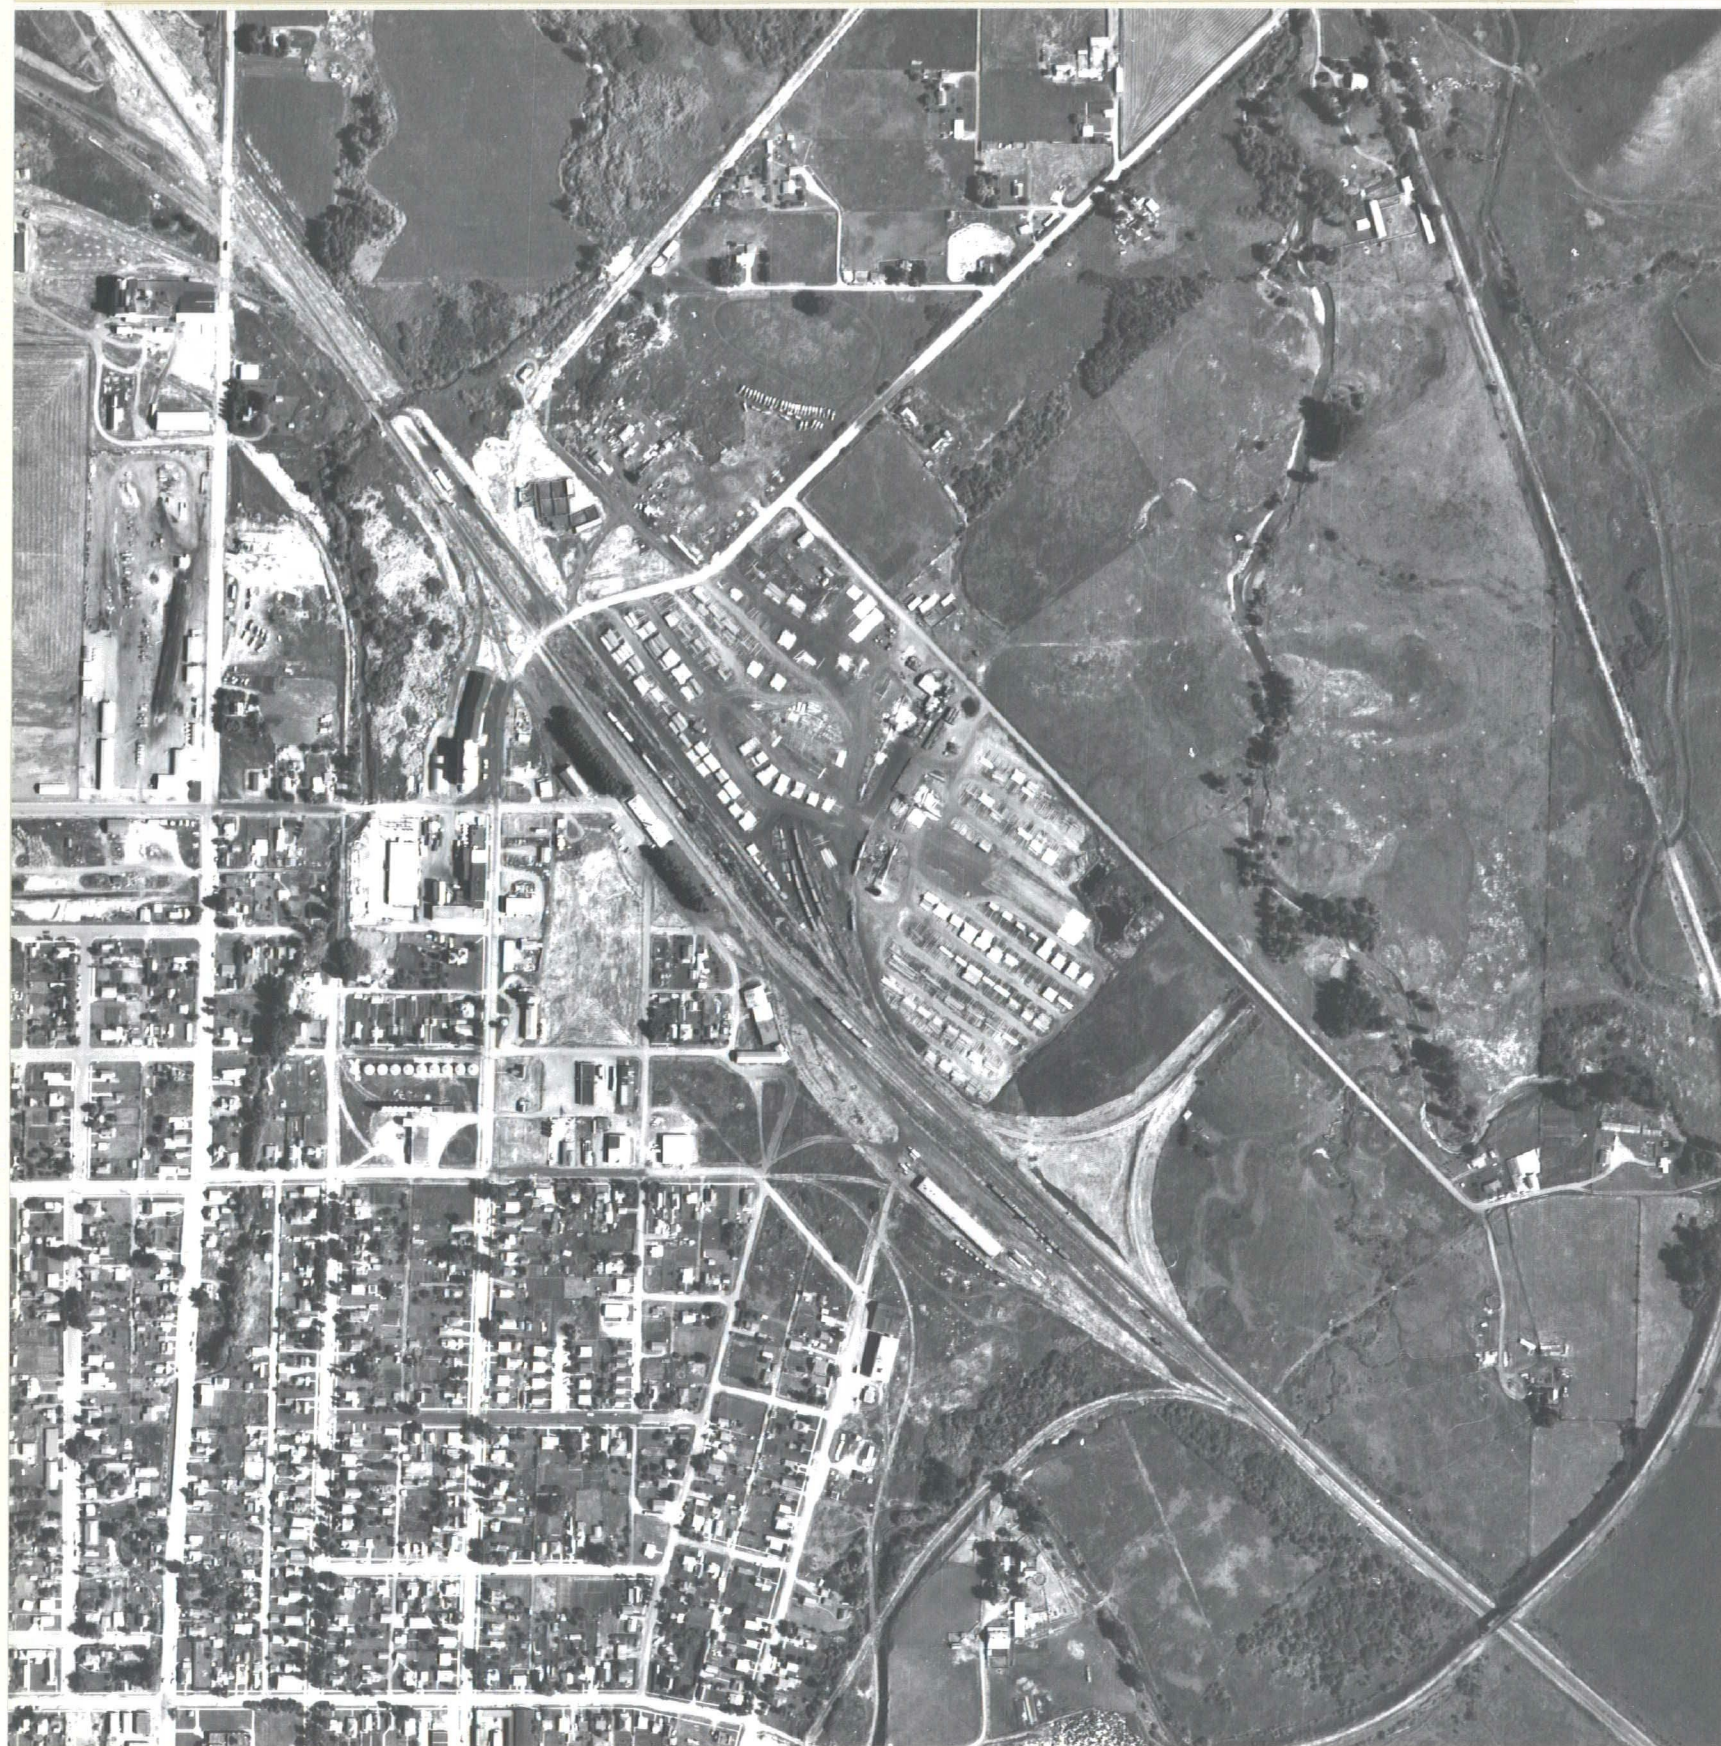
Figure 12. Idaho Pole Company, July 18, 1965. Approximate scale 1:6,650.

The 1965 photograph (Figure 12) shows an active wood treatment facility. Since 1954 the quantity of stacked poles has increased and the open storage yards are enlarged. A saw building is identified next to the wood treatment building.

The surface runoff from this facility has accumulated in a terrain depression (annotation "A") at the east side of the facility and in a lagoon adjacent to the treatment building. A drainage ditch described on the 1954 photograph (Figure 11, annotation "A") appears to be blocked causing the backup of standing liquid (annotation "A"). The lagoon next to the treatment building is likely to contain waste liquids from wood treatment. There are no signs of leachate or vegetation stress at this facility.
